# Ecological condition of the riverbanks of the Cacaluta river, Chiapas, México

**Objective** To evaluate the bank quality of the river Cacaluta, Chiapas, Mexico, using a structural and functional approach applying the RQI index.

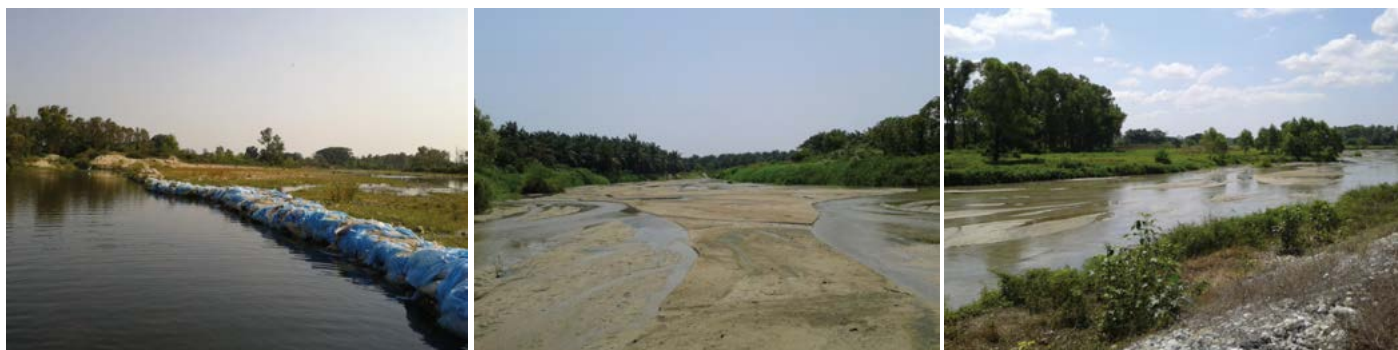
**Figure 2.** From left to right: diversion of water with a barrier of sandbags, silted channel, laminar flow over a sandy bed surrounded by oil palm crops and effects of river channeling in the lower reaches. Photographs taken in the field by the author Jorge Hernández Hernández.
