Salinity and microbiological risk assessment in surface runoff and main tributaries to La Vega Dam in Teuchitlán, Jalisco, Mexico

Objective: This research aimed to evaluate the water quality of the main tributaries to the La Vega Dam for irrigation purposes through the physicochemical and microbiological parameters.

Design/methodology/approach: The 10 main tributaries to the La Vega Dam were selected. The variables evaluated were pH, Temperature, Electrical Conductivity, Total Dissolved Solids and Dissolved Oxygen, boron calcium, magnesium, sodium, SAR, and RSC.

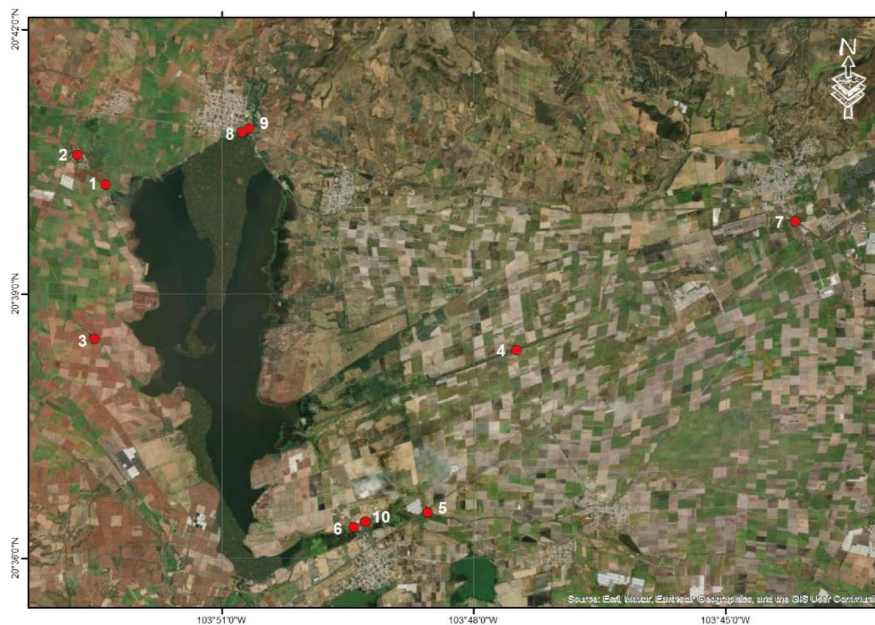
Figure 1. Sampling site locations.

The 10 main tributaries to La Vega Dam were selected; the coordinates of the sites are shown in Table 1 and Figure 1. A land vehicle was used to collect samples, and the sites were located using a GPS (Etrex Garmin® brand).
